END LINE ASSESSMENT REPORT FOR TREE PLANTATION AT NASHIK HIGHWAY

2022

This report is the **End line assessment** report of year 2022 for verification of report submitted for 40Km of identified stretch from Pimpalgaon- Igatpuri national highway (NH-3). As part of verification, number of newly planted trees/shrubs and species in right of way (ROW) both on right and left side were assessed. Filed observation like height of plant, girth of plant, distance from road and embankment, distance between ROW and Plants, encroachments in ROW, damaged tree guard, damaged plants were conducted.

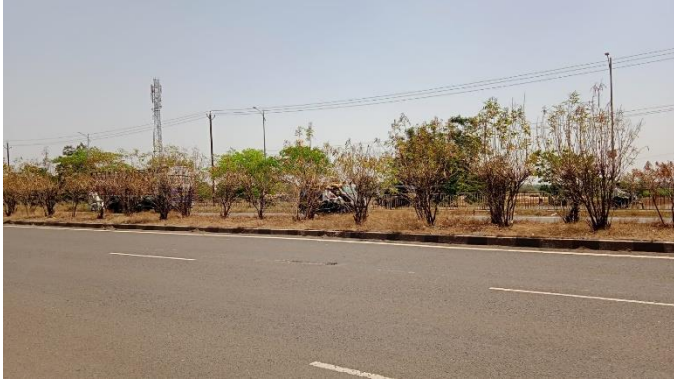
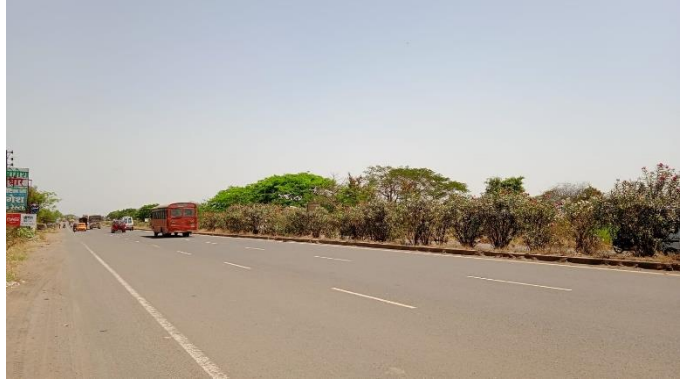
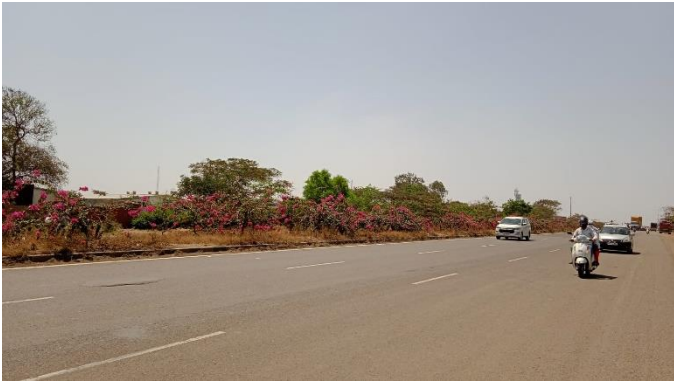
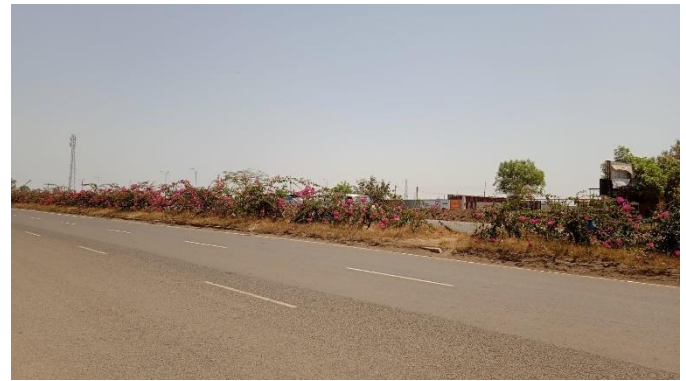
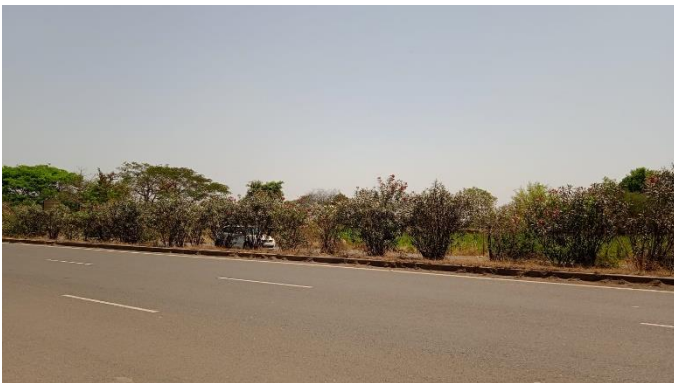
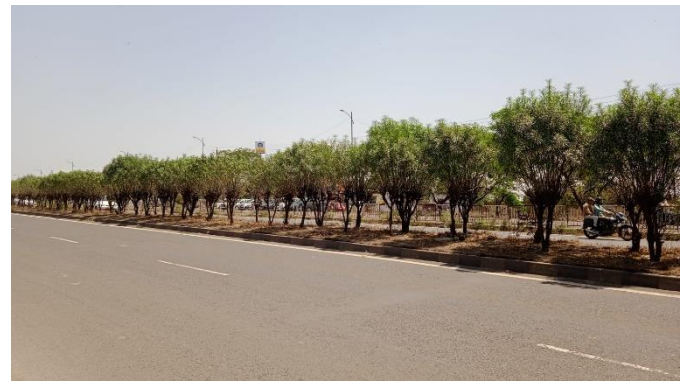
No New Plants have been planted in median. The number were found same as previous one. Trimming and cutting of median were well observed and still ongoing process.

Below are some picture evidence showing Median.

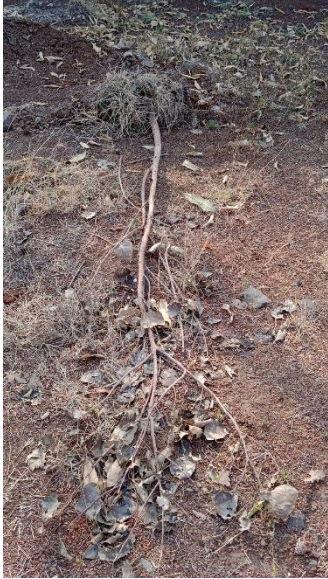
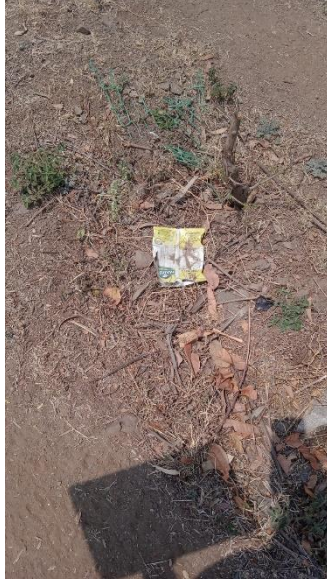
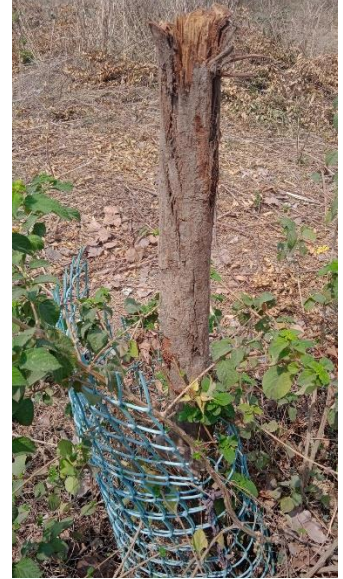
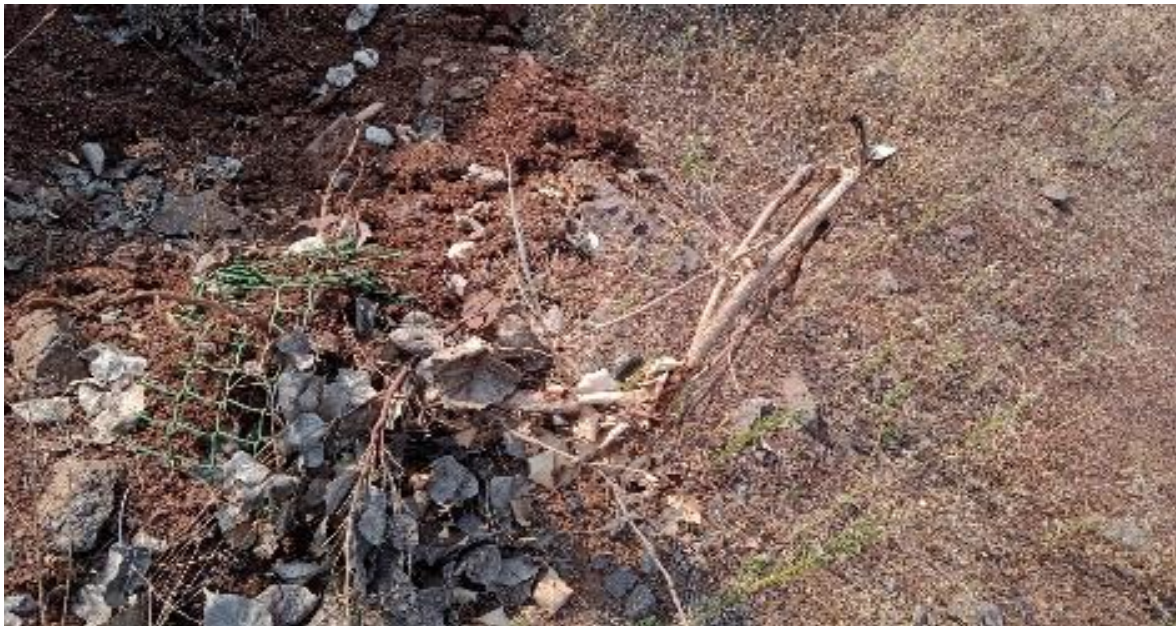
Dead Plants

There are total 315 plants on Left hand side and 456 plants on Right hand side reported to be dead. Tree guard found were not in good shape also they were negligible in number.

SIDE	Dead Tree	Alive Tree	Total Tree	Survival Rate
LHS	358	4494	4852	92.62
RHS	594	5362	5956	90.02
Total	952	9856	10808	91.19

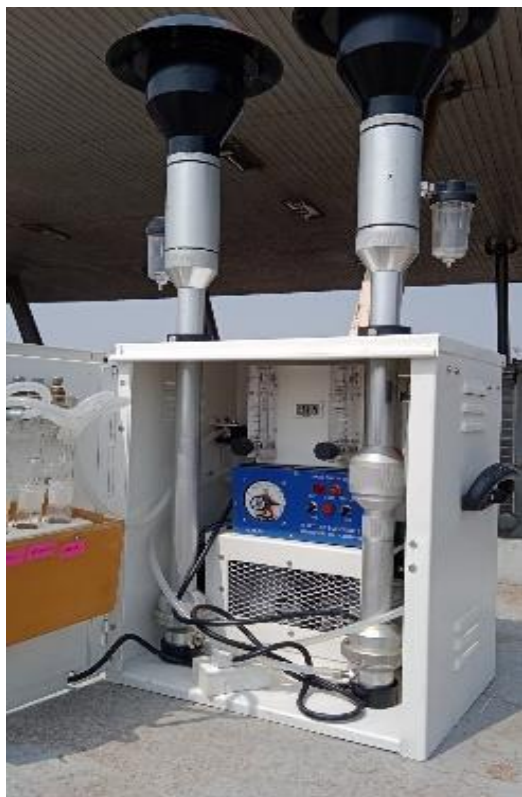
On identified stretch at one locations air quality sample was taken and air quality testing was done from NABL accredited lab of Mumbai for different parameters. Since constrain of power source available on highway, only one air sampling was done at pimplegaon side at toll plaze.

Air Sampling Unit

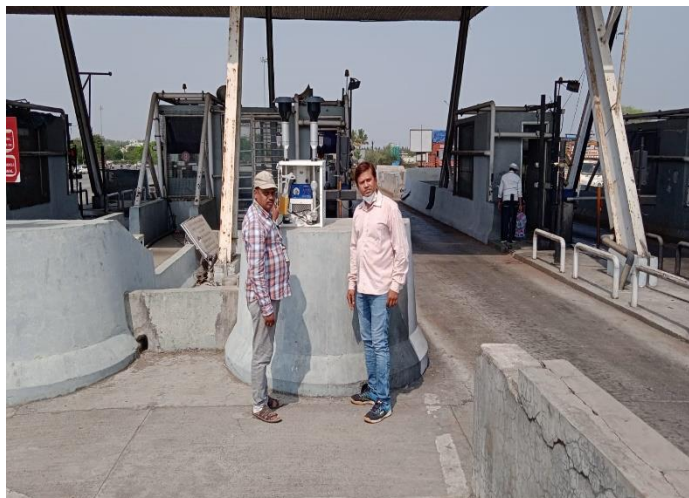
- Air Sampling Record was completed detailing time of sampling, sampling interval, and signed by the person collecting the sample.
- Grab Sampling method was used in which air sample is taken for particular period of time
- After the sample was collected, air-sampling instrument was properly capped to prevent contamination.
- Sampled air has been sent to NABL Accreditations Laboratory for analysis

Taking out Air Sample

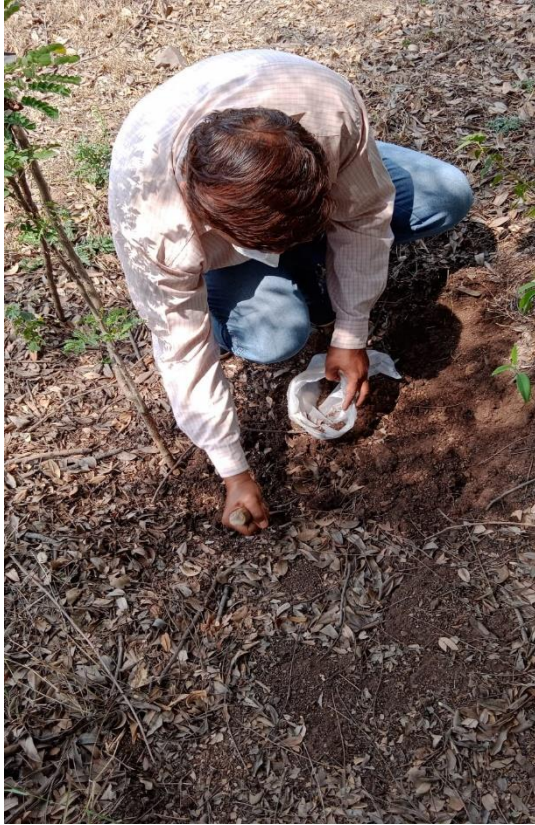
- Cleaning of any contaminating chemicals or dirt on surface level has been done using tools like spade.
- Removable of any dead plants, scrape mulch and leaf litter from the soil surface. Soil digging was done about 3 to 4 inches deep.
- Removal of dead roots, worm, rock etc. had been done carefully
- Soil sample (500 gram) has been taken into bag/container and sealed to prevent contamination of sample
- Total of 2 sample has been taken in identified stretch except Nasik city limit
- Each sample has been levelled with respective location and sent to NABL accredited laboratory for analysis.

Cleaning and digging before taking soil

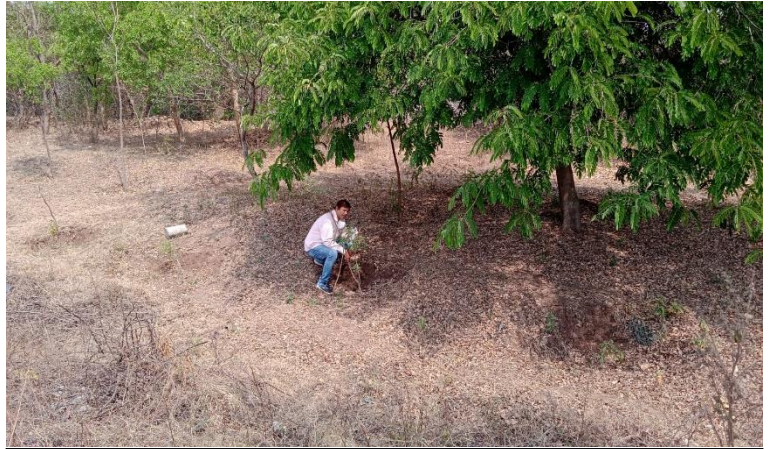
Samples were collected using soil auger/spade. About 500 grams of soil was collected in each Sample and with systematic labelling these were transported to well-equipped lab of Mumbai by trained professional. All standard precautions were taken to prevent sample contamination and recommended sampling depth was ensured at all sites to get accurate test results.

Taking soil sample
